PT
TECHNICAL REPORT M-170

Characterization of Fracture of Engineering Materials

FRACTURE CHARACTERISTICS OF STRUCTURAL
STEELS AND WELDMENTS

by
J. Aleszka
Y. G. Kim

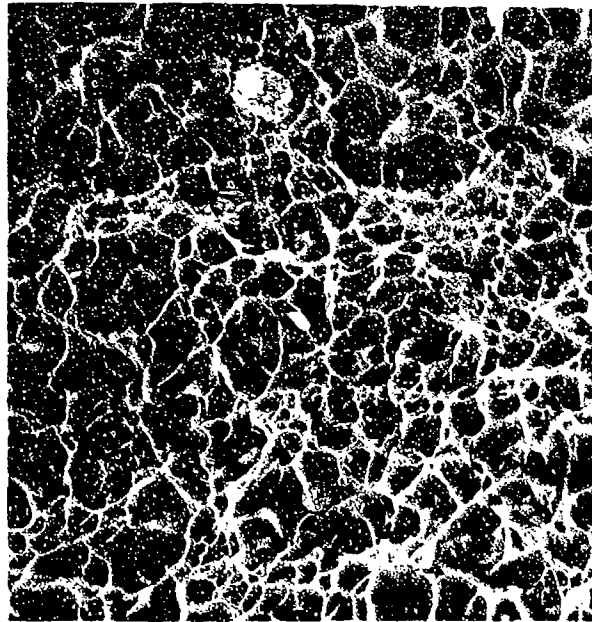
Figure 117. Tensile failure of AX-110 weld material by dimple rupture, 4000x.

Figure 116 shows the fracture surface of a solid AX-110 weld deposit tested in tension. Failure occurred by microvoid coalescence and dimple rupture (Figure 117). Exposure of an AX-110 weld tensile sample to hydrogen-charging prior to testing produced the fracture surface shown in Figure 118. In one area of the surface small fisheyes were present (Figure 119). The fisheye region (Figure 120) consisted of very small cleavage facets (Figure 121). This failure mode resulted from pockets of entrapped hydrogen gas. The rest of the specimen failed by microvoid coalescence (Figure 122). When the tensile specimens were temper-embrittled prior to testing, the fracture surface (Figure 123) consisted of dimple rupture and microvoid coalescence (Figure 124).

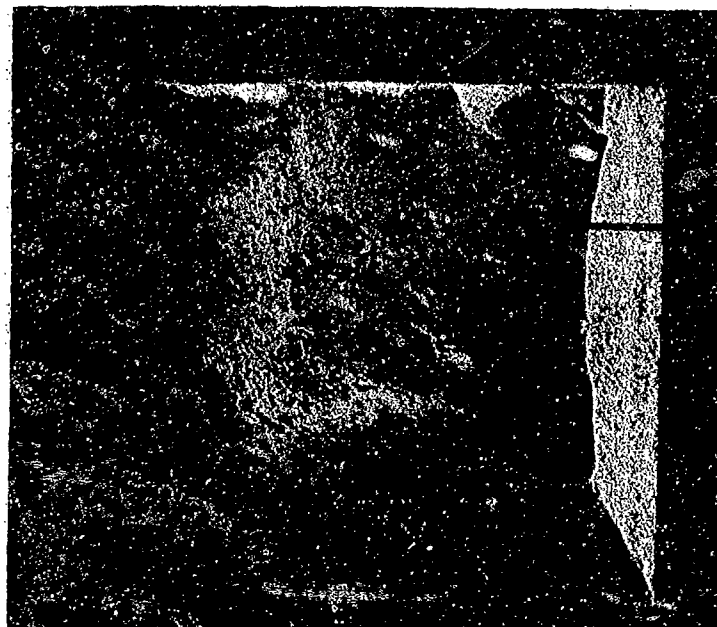
Figure 123. Tensile fracture surface of temper-embrittled AX-110 weld specimen, 15x.

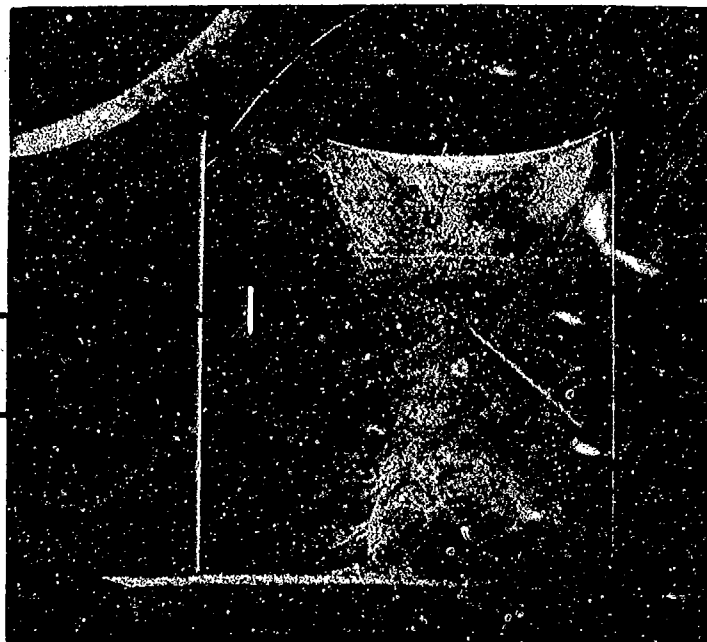
Figure 125. Fatigue fracture surface of an AX-110 weld specimen, 11x.

The fracture surface of a solid AX-110 weld tested in fatigue is shown in Figure 125. The fatigue region consisted of parallel microcracks rather than striations (Figure 126). As the crack advanced into the center of the specimen, the failure mode changed from fatigue to tensile overload by microvoid coalescence. When the crack was large enough to cause rapid tensile overload, failure occurred by dimple rupture and microvoid coalescence (Figure 127).

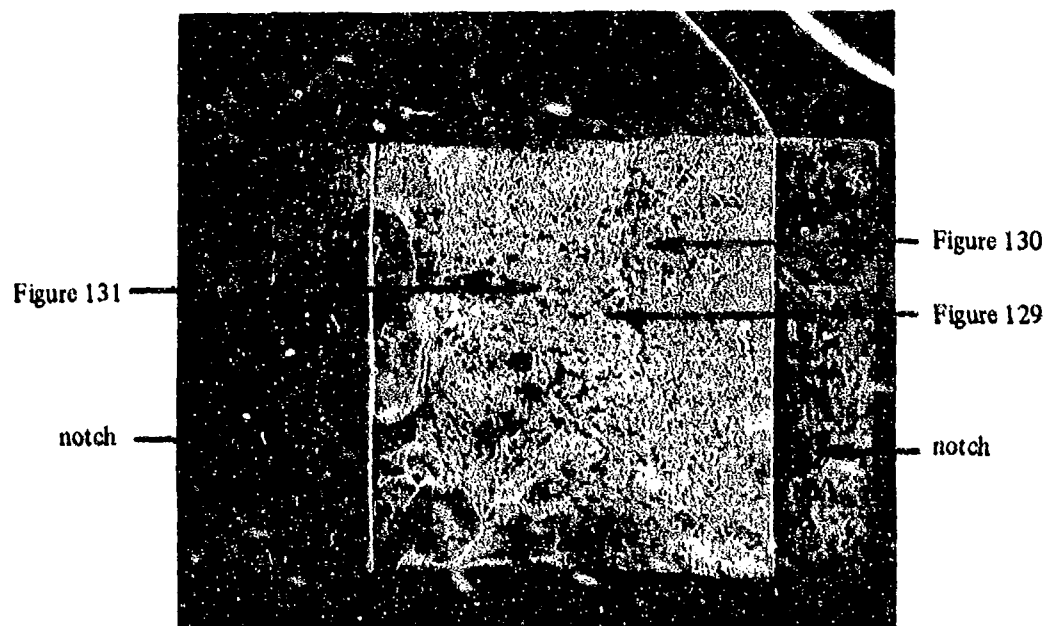
Figure 128. Fatigue fracture surface of hydrogen-embrittled AX-110 weld specimen, 10x.

When the weld test specimen was hydrogen-embrittled prior to fatigue testing, the fracture surface (Figure 128) was similar to that of the hydrogen-embrittled T-1 plate specimen (Figure 54), except for the presence of large facets on one side of the weld fracture surface. The fatigue regions consisted of numerous small craters, many of which contained microcracks (Figure 129). Fatigue striations with multiple orientations (Figure 130) were present on the fracture surface around the craters. There was evidence of crater formation even in the central region where failure occurred by dimple rupture and microvoid coalescence (Figure 131).

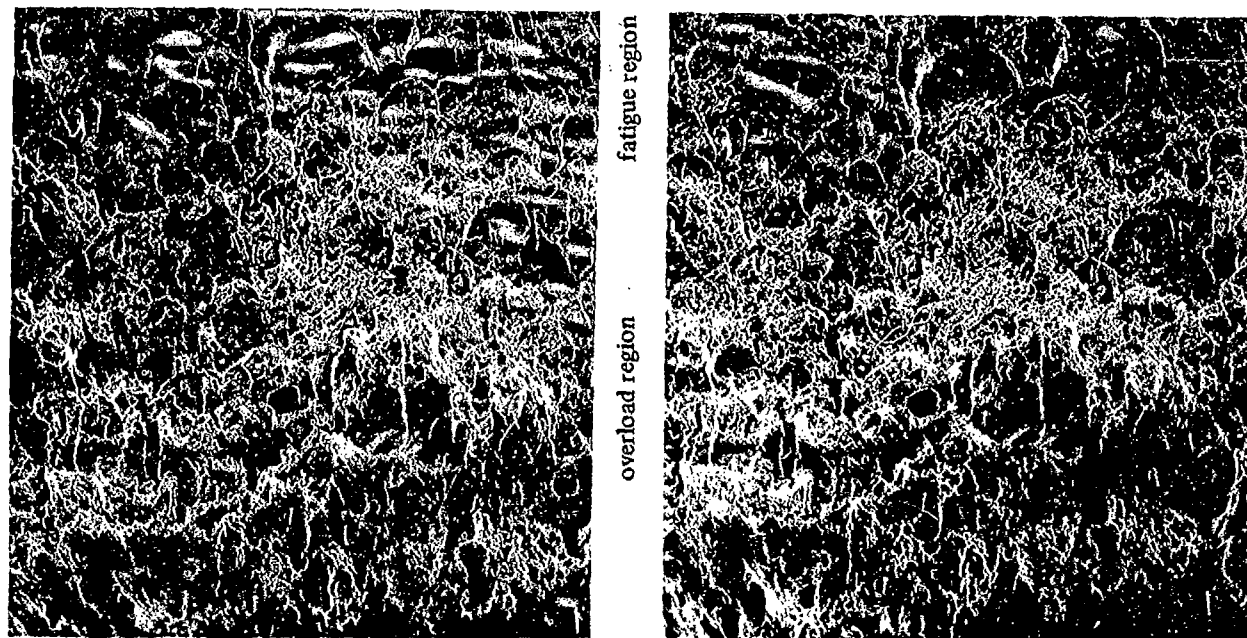
Figure 129. Stereo micrograph of fatigue region in a hydrogen-embrittled AX-110 weld specimen, 40x.

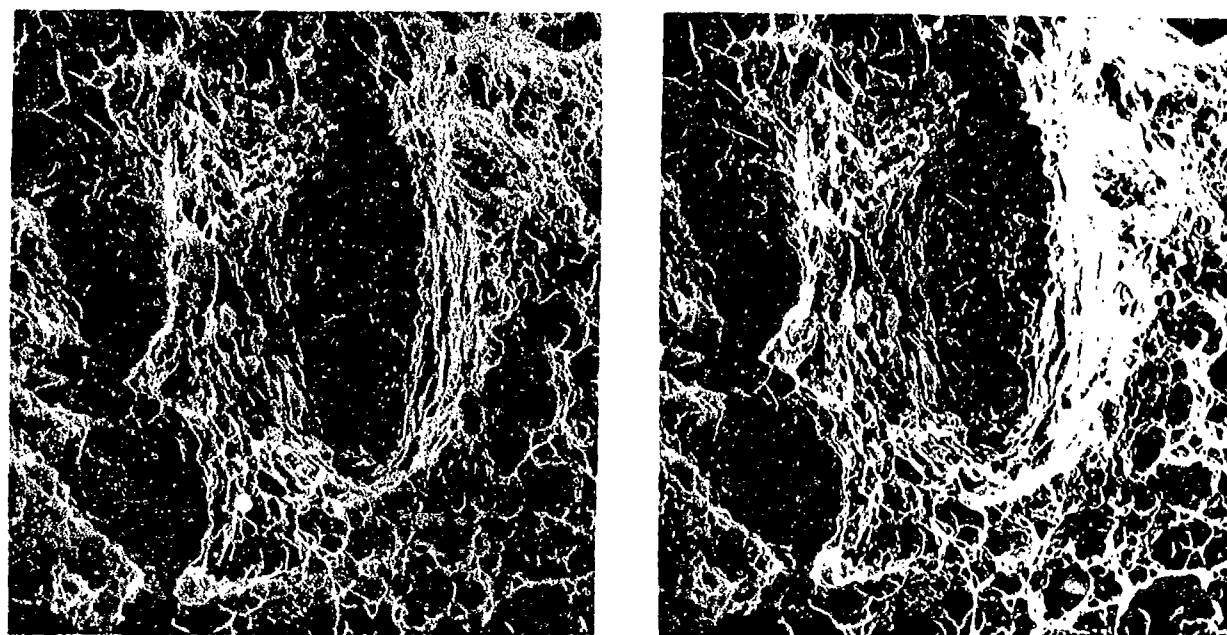
Figure 131. Stereo micrograph of the tensile overload region in a hydrogen-embrittled AX-110 weld fatigue specimen, 1600x.

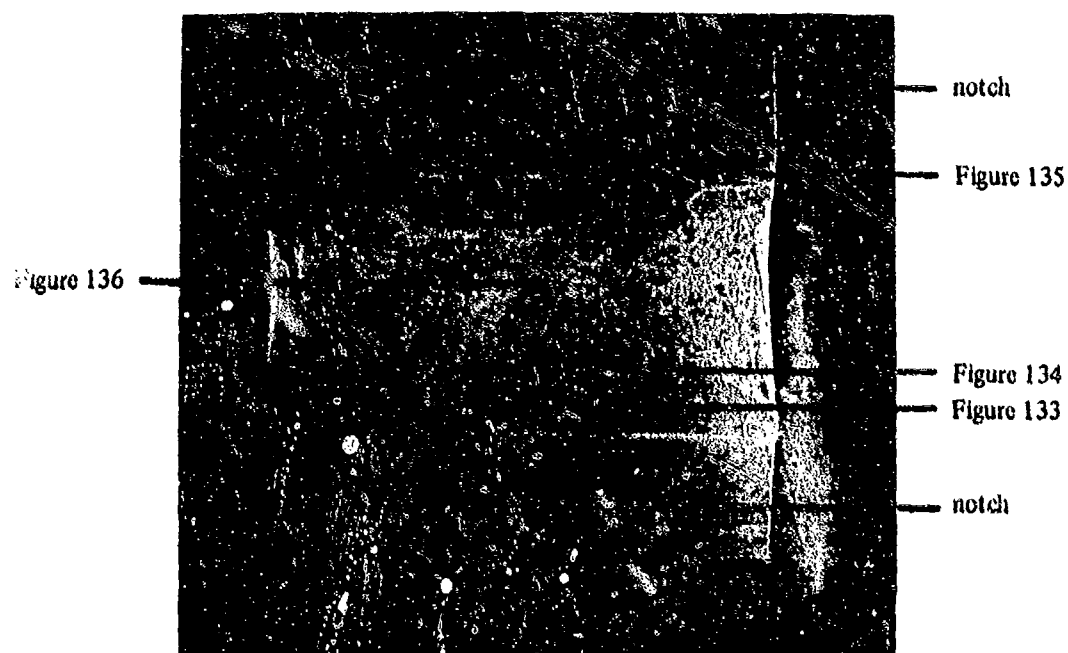
Figure 132. Fatigue fracture surface of temper-embrittled AX-110 weld specimen, 11x.

shown in Figure 132. The fatigue region (Figure 133) contained relatively few distinct fatigue patterns (Figure 134). There was evidence of lamellar tearing near the transition region from the fatigue to tensile overload failure mode (Figure 135). Failure in the overload region occurred by dimple rupture and microvoid coalescence (Figure 136).

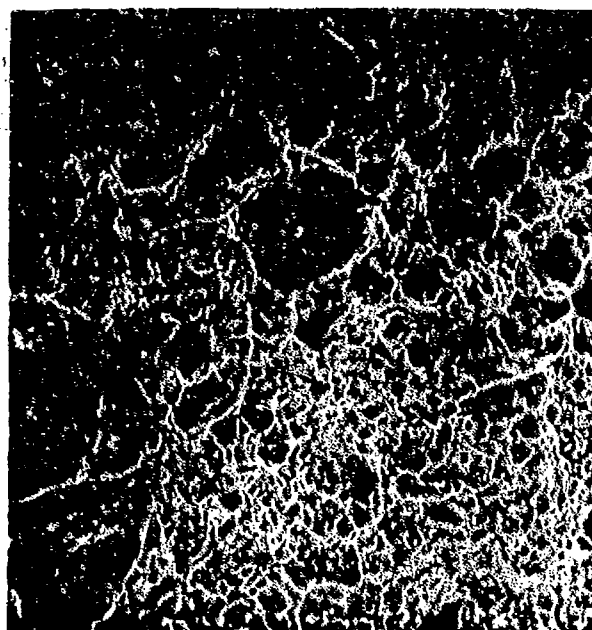
Figure 136. Tensile overload region in temper-embrittled AX-110 weld fatigue specimen, 750x.

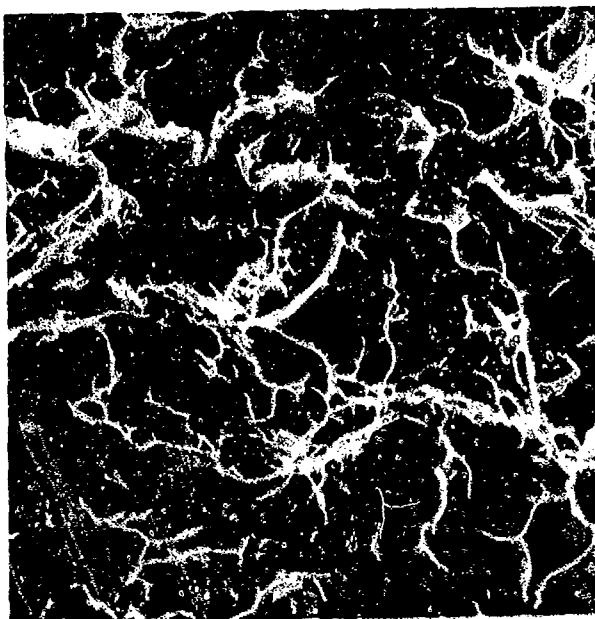
Figure 141. Failure of AX-110 weld Charpy specimen tested at -196°C by cleavage, 4000x.

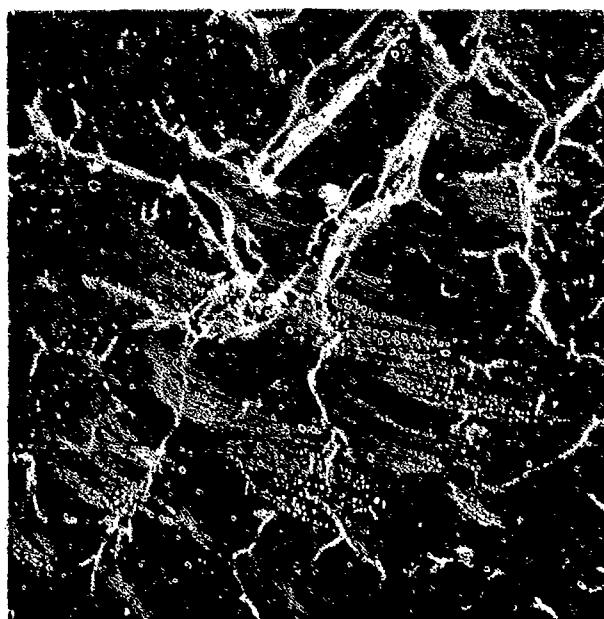
Figure 142. Center of AX-110 weld Charpy specimen tested at -83°C , 4000x.

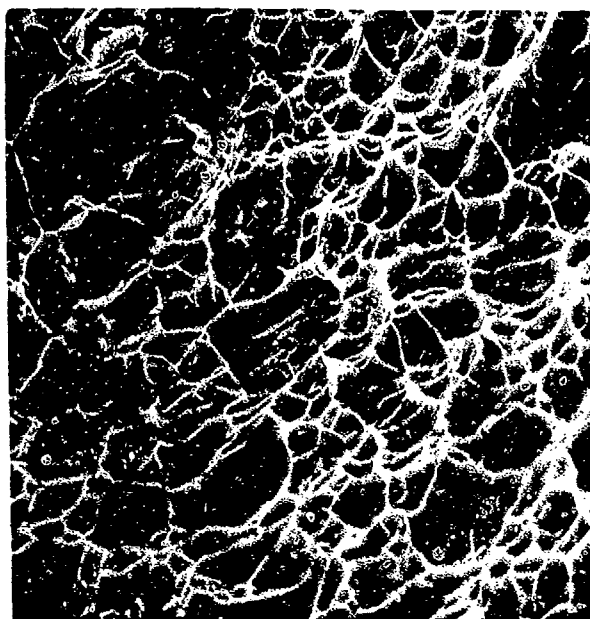
Figure 143. Edge of AX-110 weld Charpy specimen tested at -83°C , 4000x.

The effects of test temperature on the fracture mode of Charpy specimens revealed the low ductile to brittle transition temperature (DBTT) characteristic of an AX-110 weld. The fracture surfaces resulting from tests conducted at -196°C , -83°C , -18°C , and room temperature are shown in Figures 137 through 140. At -196°C , failure occurred entirely by cleavage (Figure 141). At the transition temperature (-83°C), mixed mode failure occurred; the central region of the specimen failed by cleavage (Figure 142), while the outer areas failed by dimple rupture (Figure 143). At -18°C and above, failure occurred entirely by dimple rupture (Figure 144).

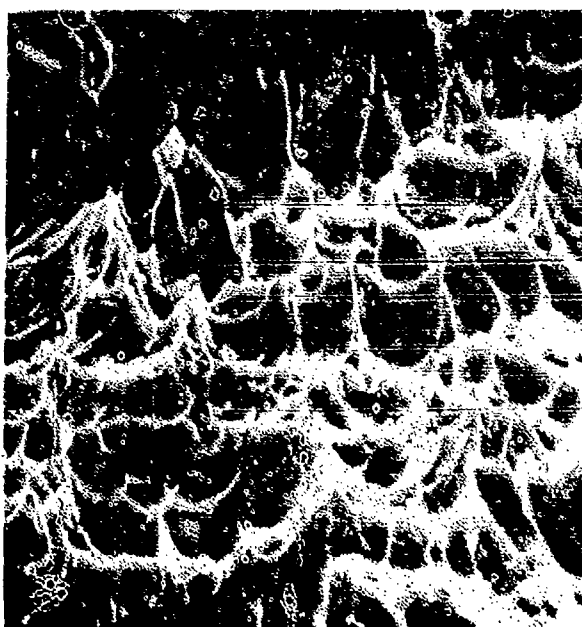
Figure 144. Fracture surface of AX-110 weld Charpy specimen tested at or above -18°C , 4250x.

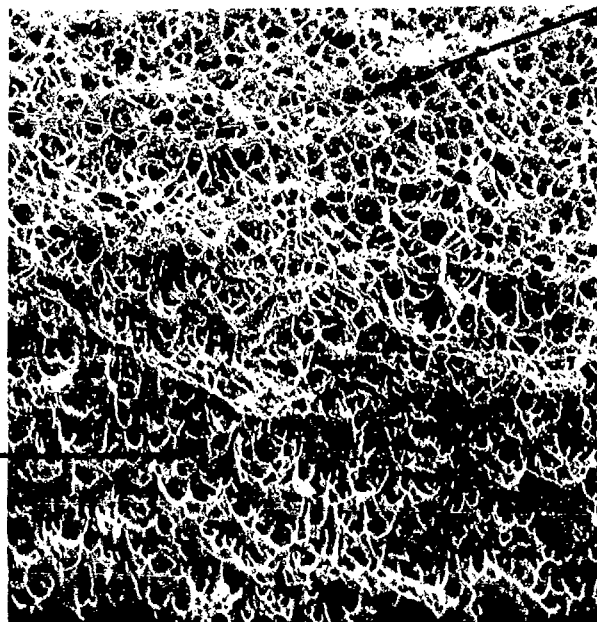
Figure 147. Transition region on tensile fracture surface of AX-110 weldment, 1900x.

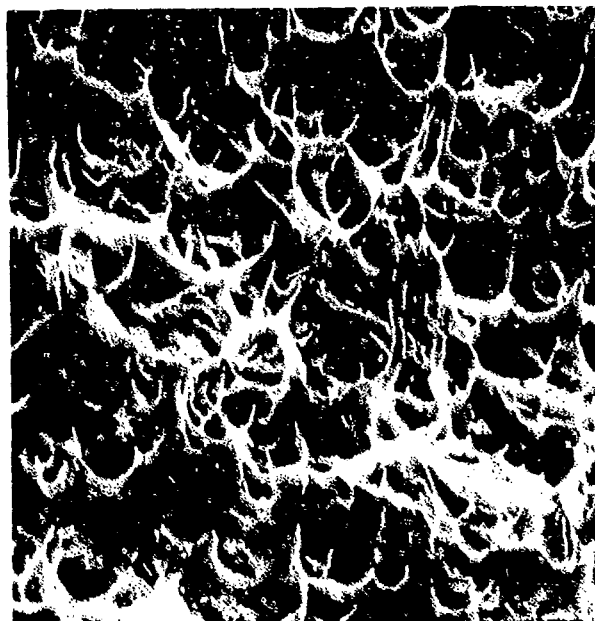
Figure 148. Elongated dimples on tensile fracture surface of AX-110 weldment, 4600x.

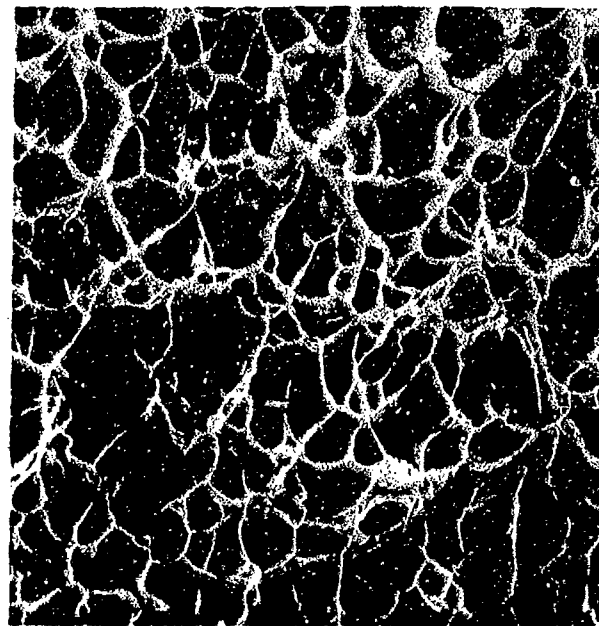
Figure 149. Equiaxed dimples on tensile fracture surface of AX-110 weldment, 4600x.

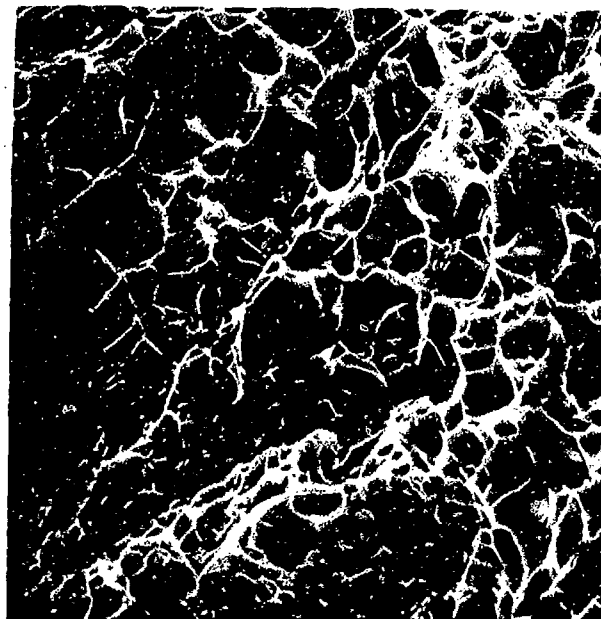
Figure 152. LOP region on tensile fracture surface of AX-110 weldment, 260x.

Figure 150 shows the fracture surface of a tensile specimen containing LOP (Figure 151) and LOP (Figure 152). The failure occurred by microvoid coalescence (Figure 153); which defect initiated it is uncertain.

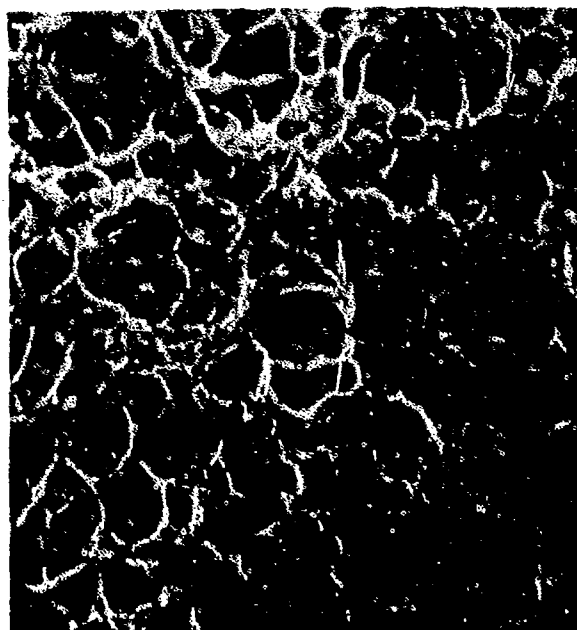
Figure 156. Fracture surface away from porosity defects, 3500x.

Figure 154 shows the tensile fracture surface of an AX-110 T-1 weldment containing porosity. The interior surface of a porosity bubble revealed dendritic growth patterns and grain boundaries (Figure 155). The fracture of the weld metal, which probably initiated in the porosity region, occurred by microvoid coalescence (Figure 156).

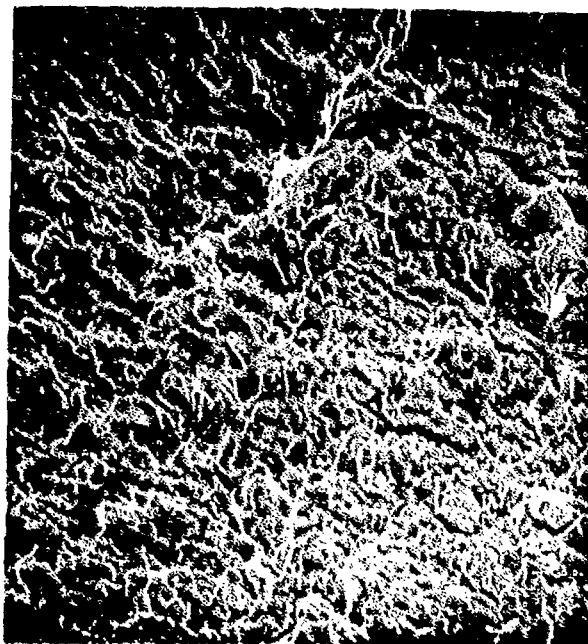
Figure 158. Fatigue region of fracture surface of AX-110 weldment containing LOP, 1700x.

center of the specimen. Fatigue striations originating from the defect were fairly well developed and easily recognizable (Figure 158). Rapid fracture in the outer portion of the specimen was by dimple rupture (Figure 159).

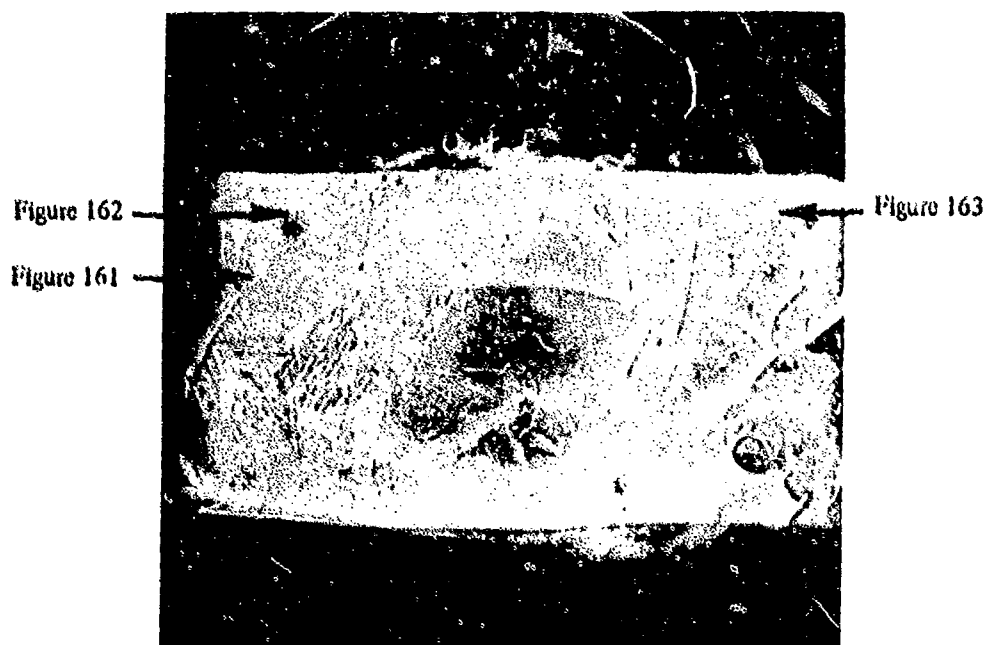
Figure 160. Fatigue fracture surface of AX-110 weldment containing porosity, 10x.

The fracture surface resulting from fatigue failure of a weldment containing porosity is shown in Figure 160. All the fatigue regions initiated at pores (Figure 161). As the crack propagated through the specimen, the fracture mode changed from fatigue (Figure 162) to dimple rupture (Figure 163).

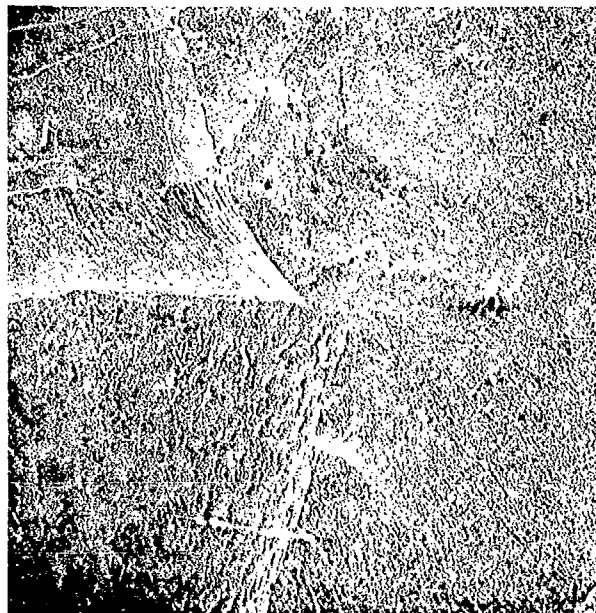
Figure 161. Fatigue initiation site on fracture surface of AX-110 weldment containing porosity, 50x.

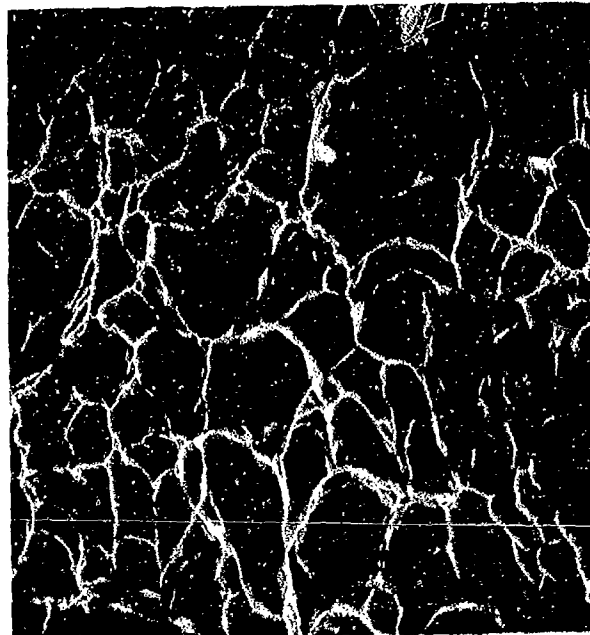
Figure 163. Tensile overload region of fracture surface of AX-110 weldment containing porosity, 1380x.

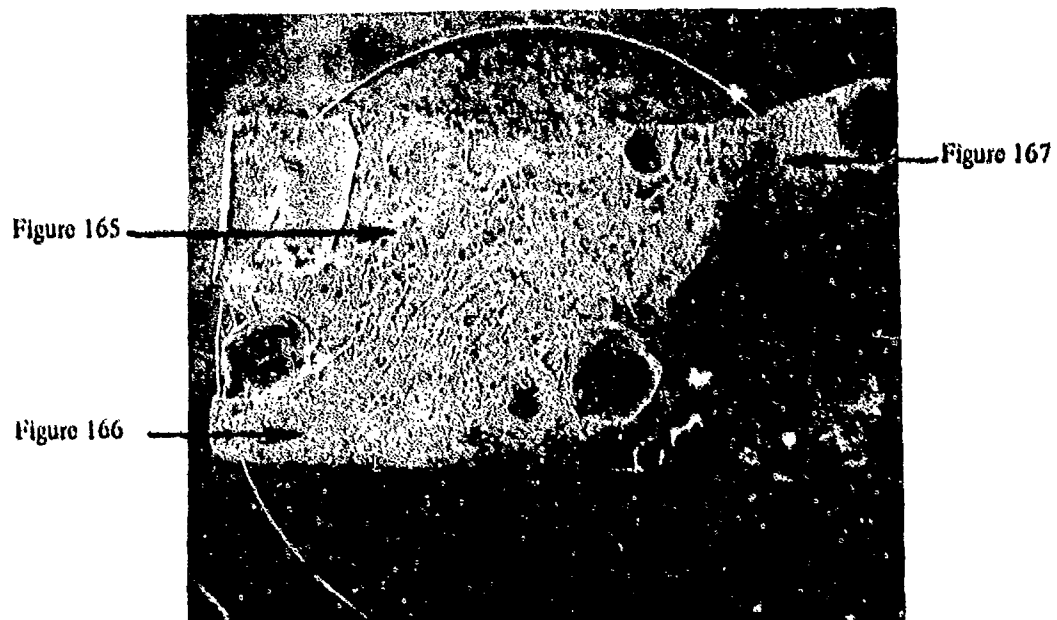
Figure 164. Fatigue fracture surface of a hydrogen-embrittled AX-110 weldment containing porosity, 8x.

Hydrogen embrittlement affected the fracture behavior of an AX-110 weldment containing porosity the same way it affected the T-1 plate and sound weld. Large parabolic contours (later confirmed as craters) pointing toward the origin of fracture were apparent on the fracture surface of an AX-110 weldment containing porosity and tested in fatigue (Figure 164). Near the center of the specimen, the craters became more circular (Figure 165). Failure initiated at an outer edge of the specimen (Figure 166). When the propagating crack reached a critical size, catastrophic failure by dimple rupture occurred (Figure 167).

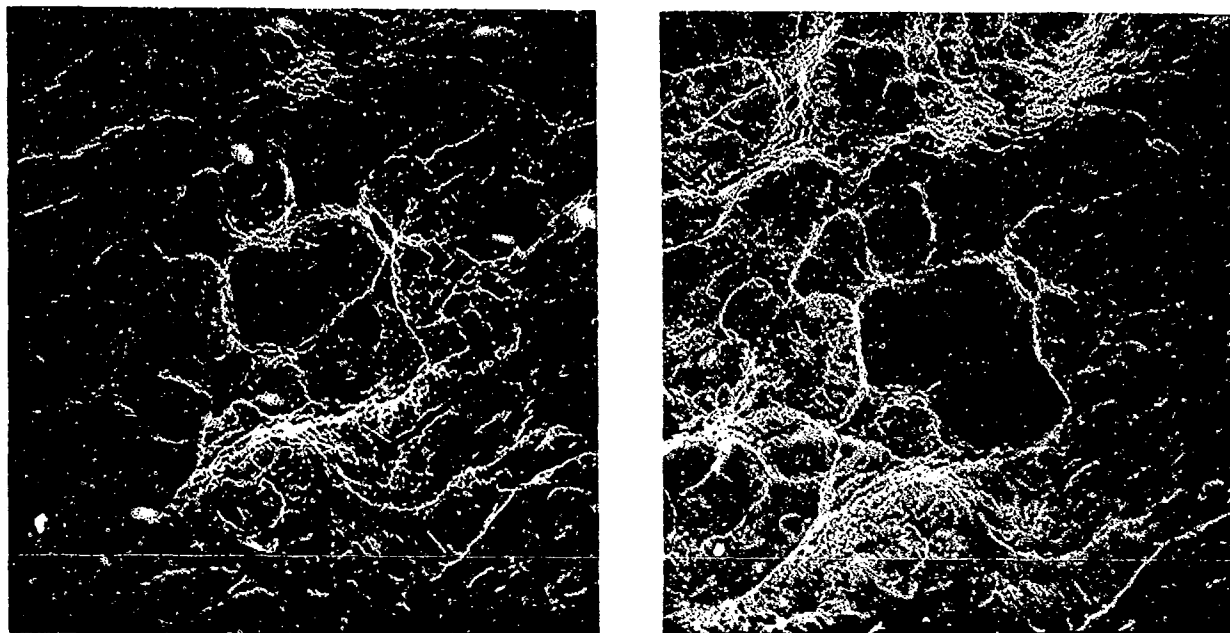
Figure 165. Stereo micrograph of fatigue region of hydrogen-embrittled AX-110 weldment containing porosity, 120x.

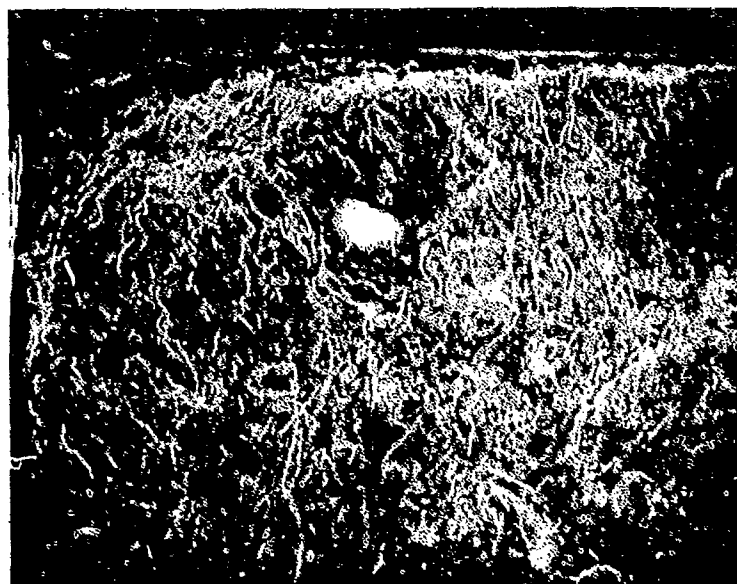
Figure 166. Origin of fatigue failure in hydrogen-embrittled AX-110 weldment containing porosity, 120x.

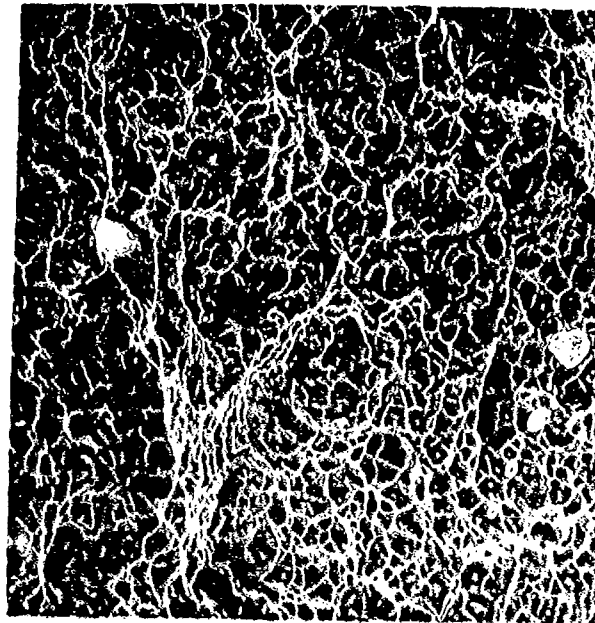
Figure 167. Tensile overload region in hydrogen-embrittled AX-110 weldment containing porosity, 1000x.

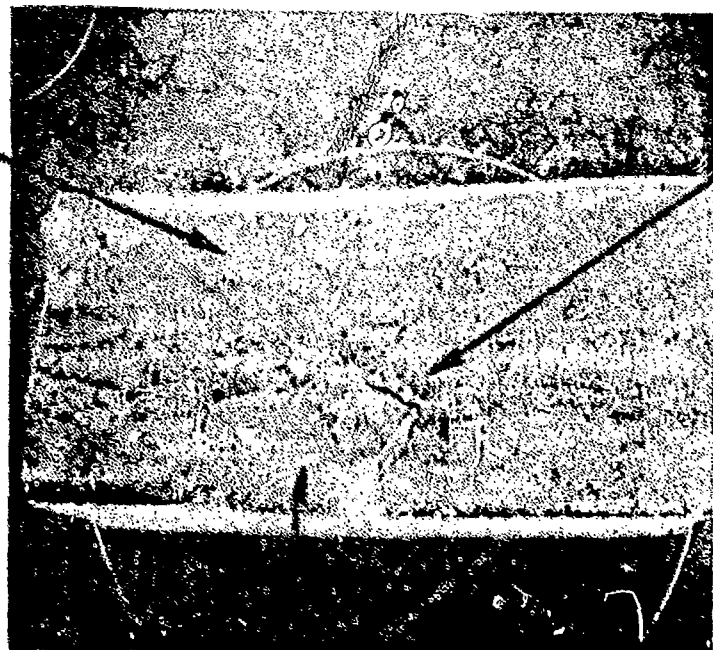
Figure 168. Fatigue fracture surface of temper-embrittled AX-110 weldment containing LOP, 8x.

Figure 168 shows the fracture surface resulting from fatigue-failure of a temper-embrittled AX-110 weldment containing LOP. Fatigue initiated from the central defect (Figure 169) and the outside edge of the specimen (Figure 170). No fatigue striations were discernible at the origin, but they became evident as the crack advanced through the material (Figure 171). The peripheral shear lip, where final fracture occurred, exhibited elongated dimples (Figure 172).

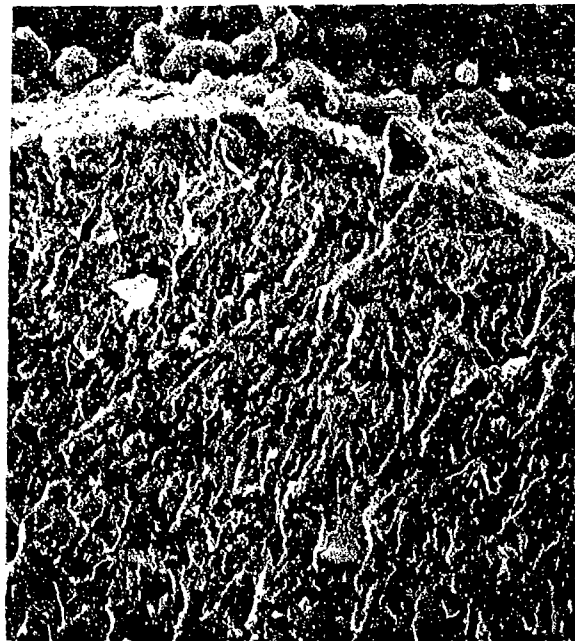
Figure 169. Origin of failure of temper-embrittled AX-110 weldment containing LOP, 1400x.
